DIRECTOR OF SHIP MATERIAL

JOINT TASK FORCE ONE

FINAL REPORT

FOR TESTS ABLE AND BAKER

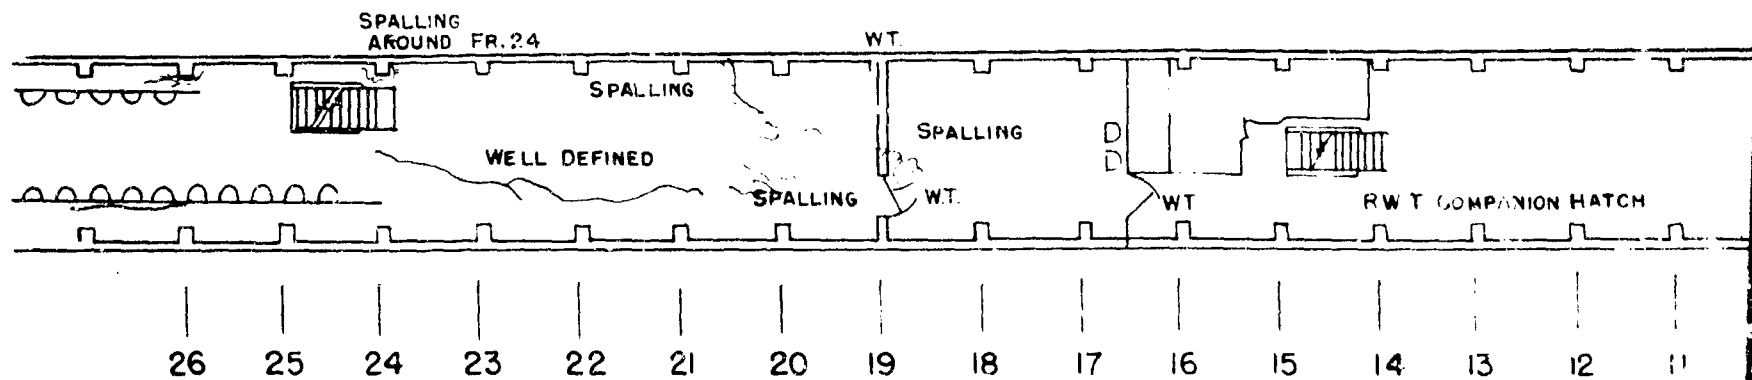
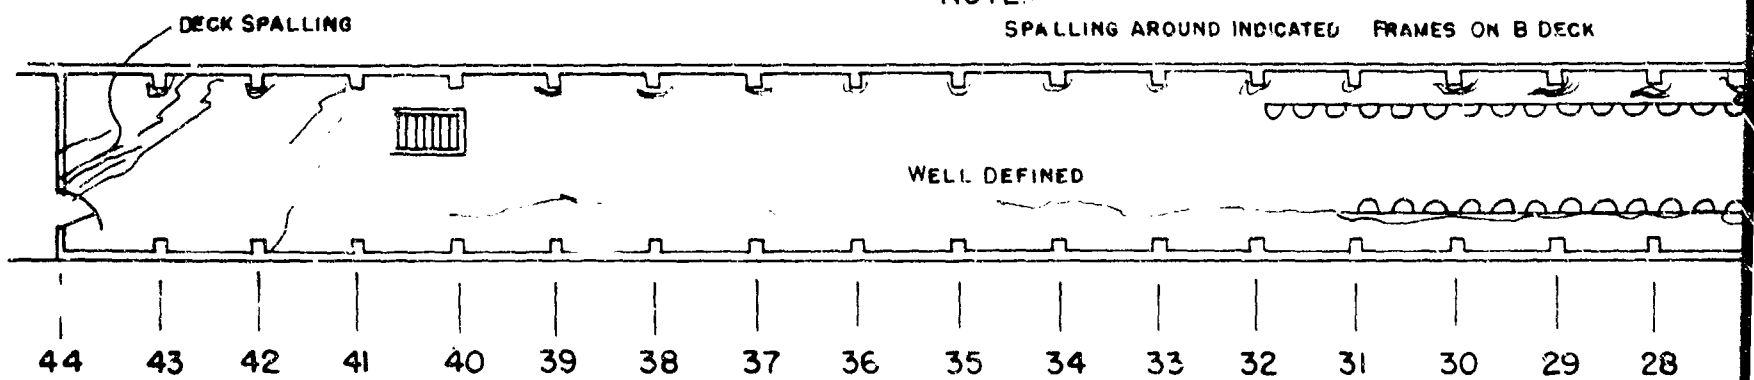
SPALLING AROUND INDICATED FRAMES ON B DECK

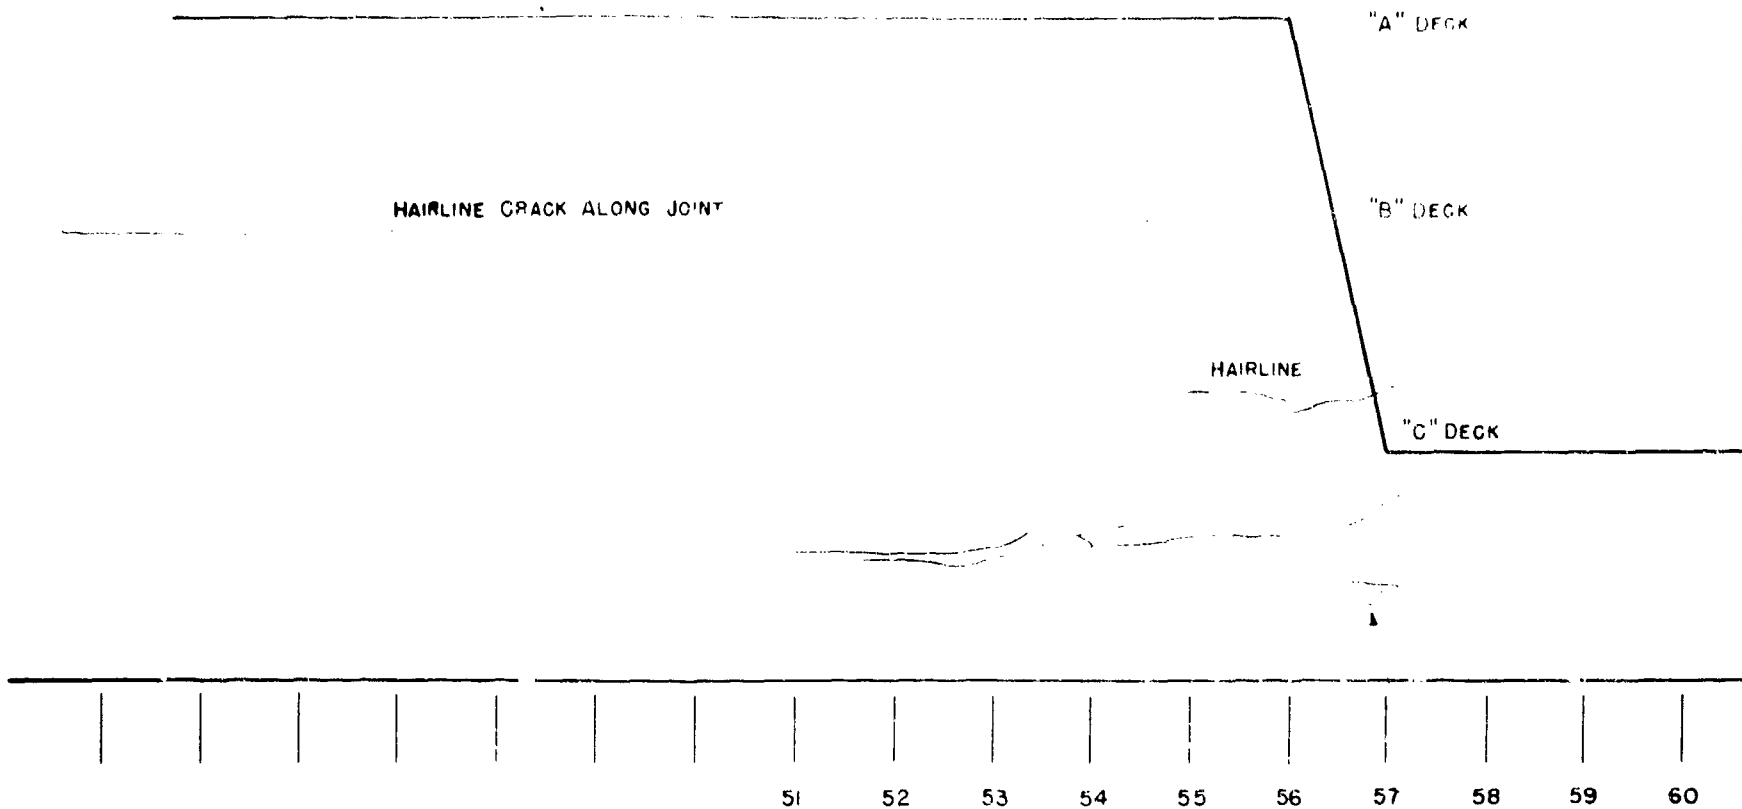
OUTSIDE FACE PORT WALL

SPALLING NOTED ON

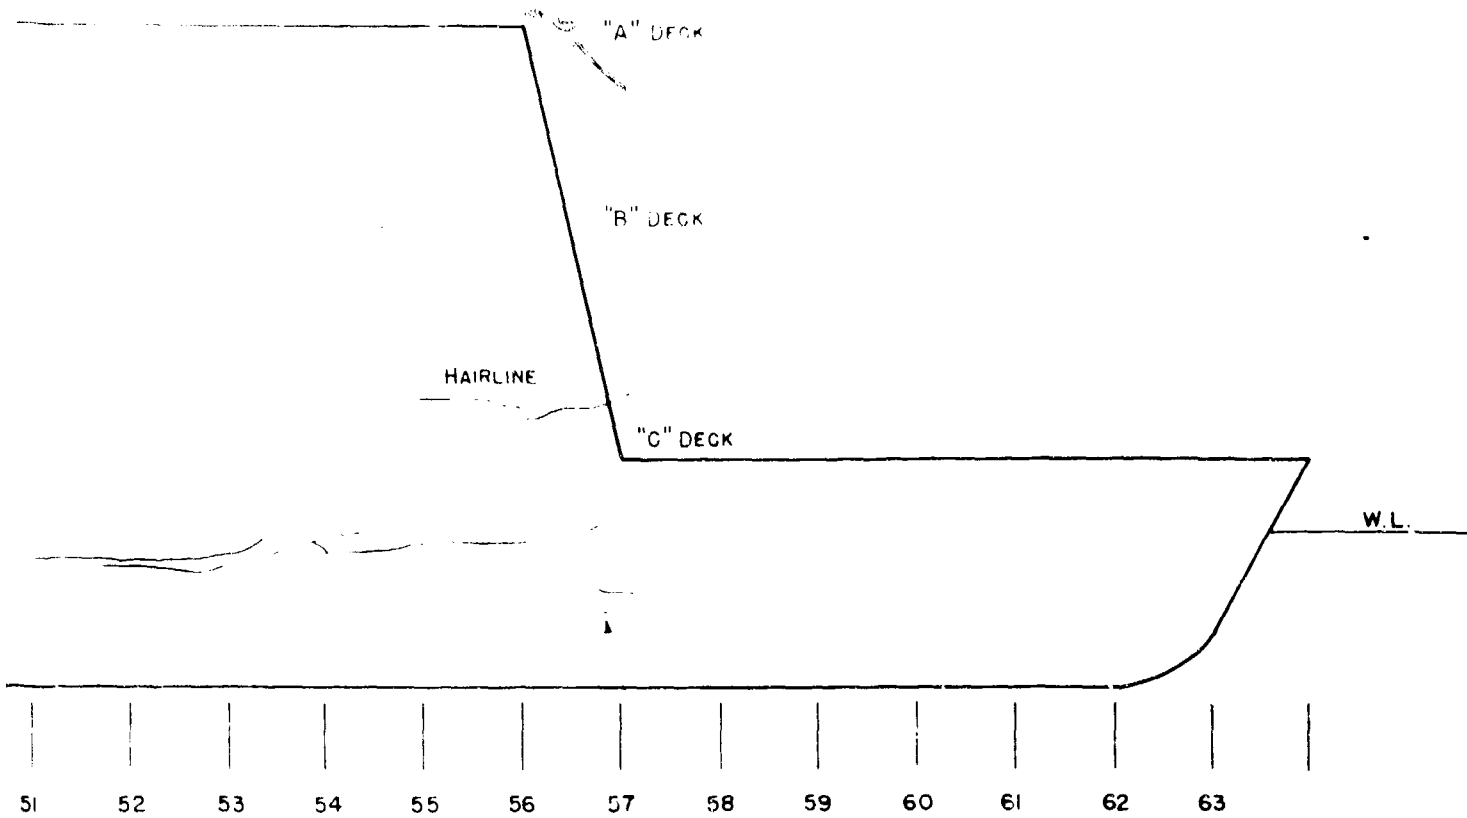
OUTSIDE FACE PORT WALL

SPALLING NOTED ON INSIDE OF DECK APPROX. 7' BELOW WATER LINE

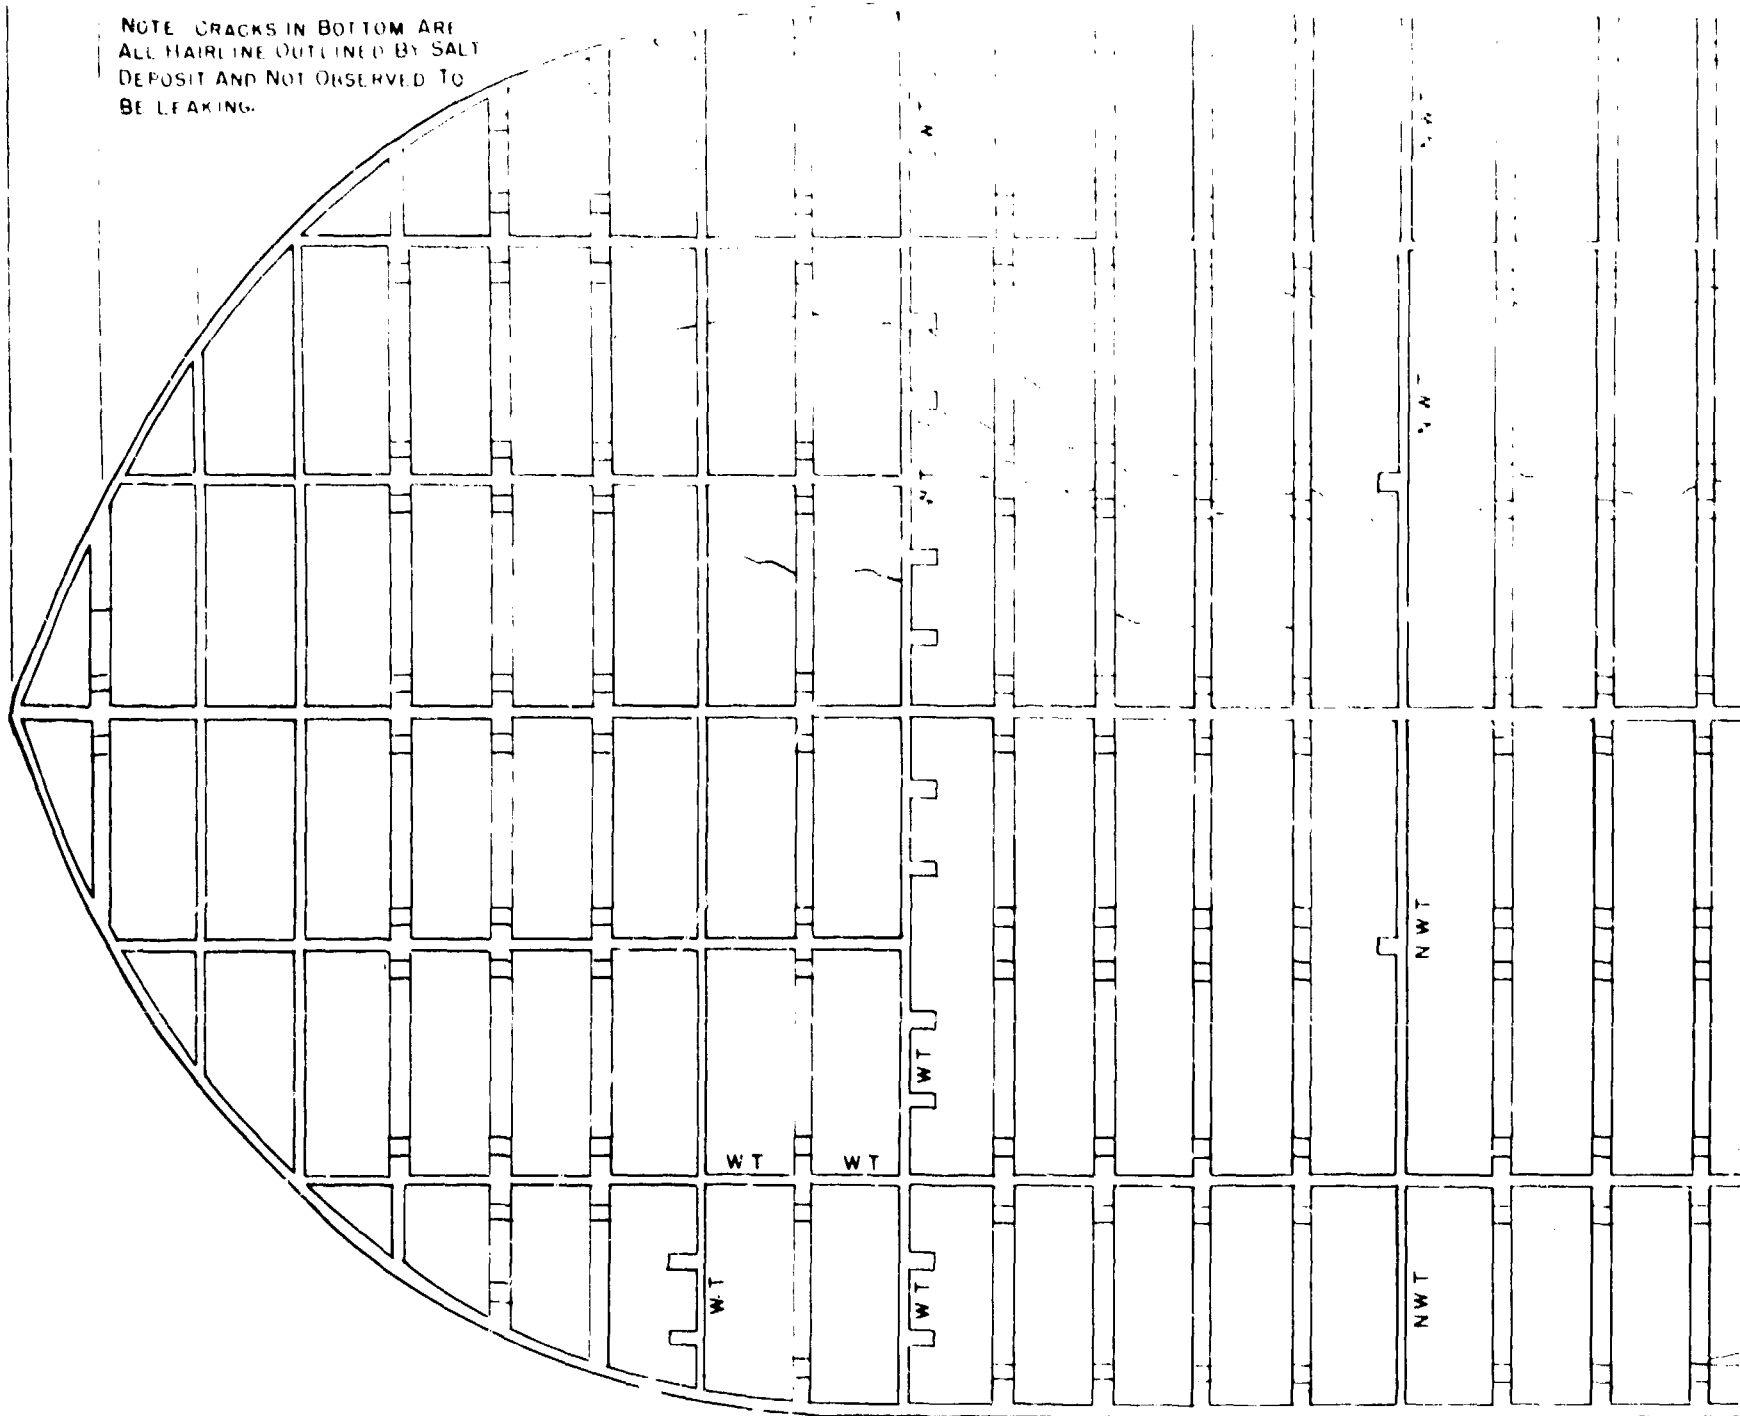
NOTE: CRACKS IN BOTTOM ARE
ALL HAIRLINE OUTLINED BY SALT
DEPOSIT AND NOT OBSERVED TO
BE LEAKING.

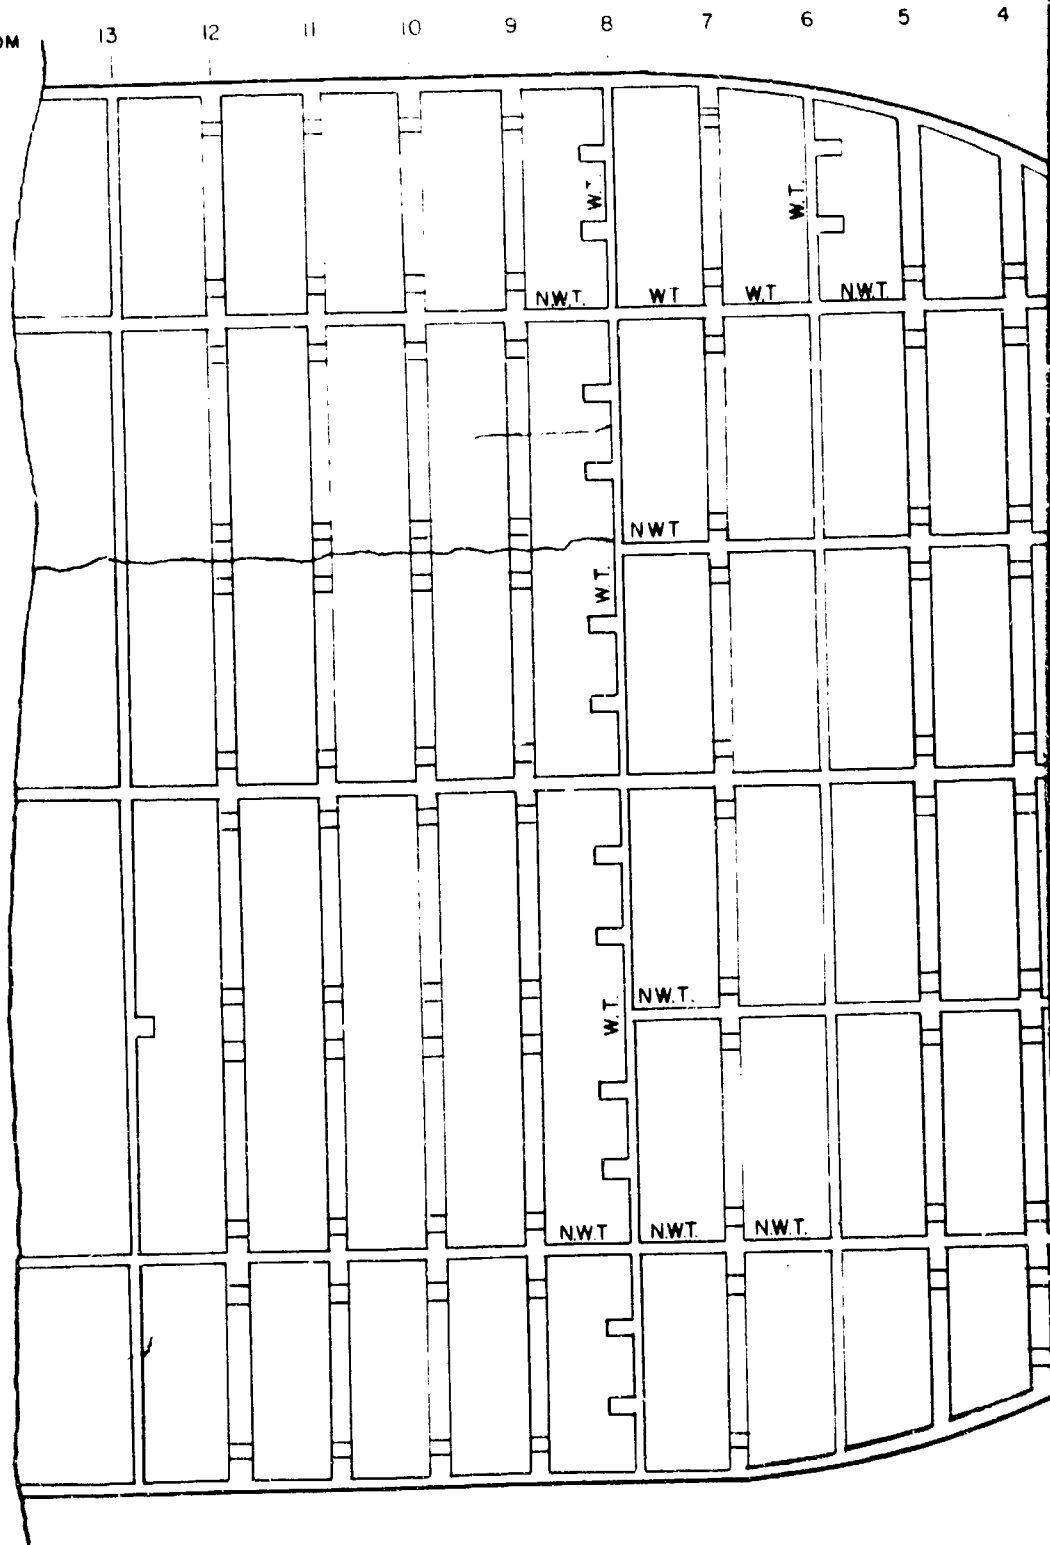
NOTE: CRACKS IN BOTTOM ARE ALL HAIRLINE - OUTLINED BY SALT DEPOSIT AND NOT OBSERVED TO BE LEAKING.

THIS CRACK EXTENDS TO FRAME 55

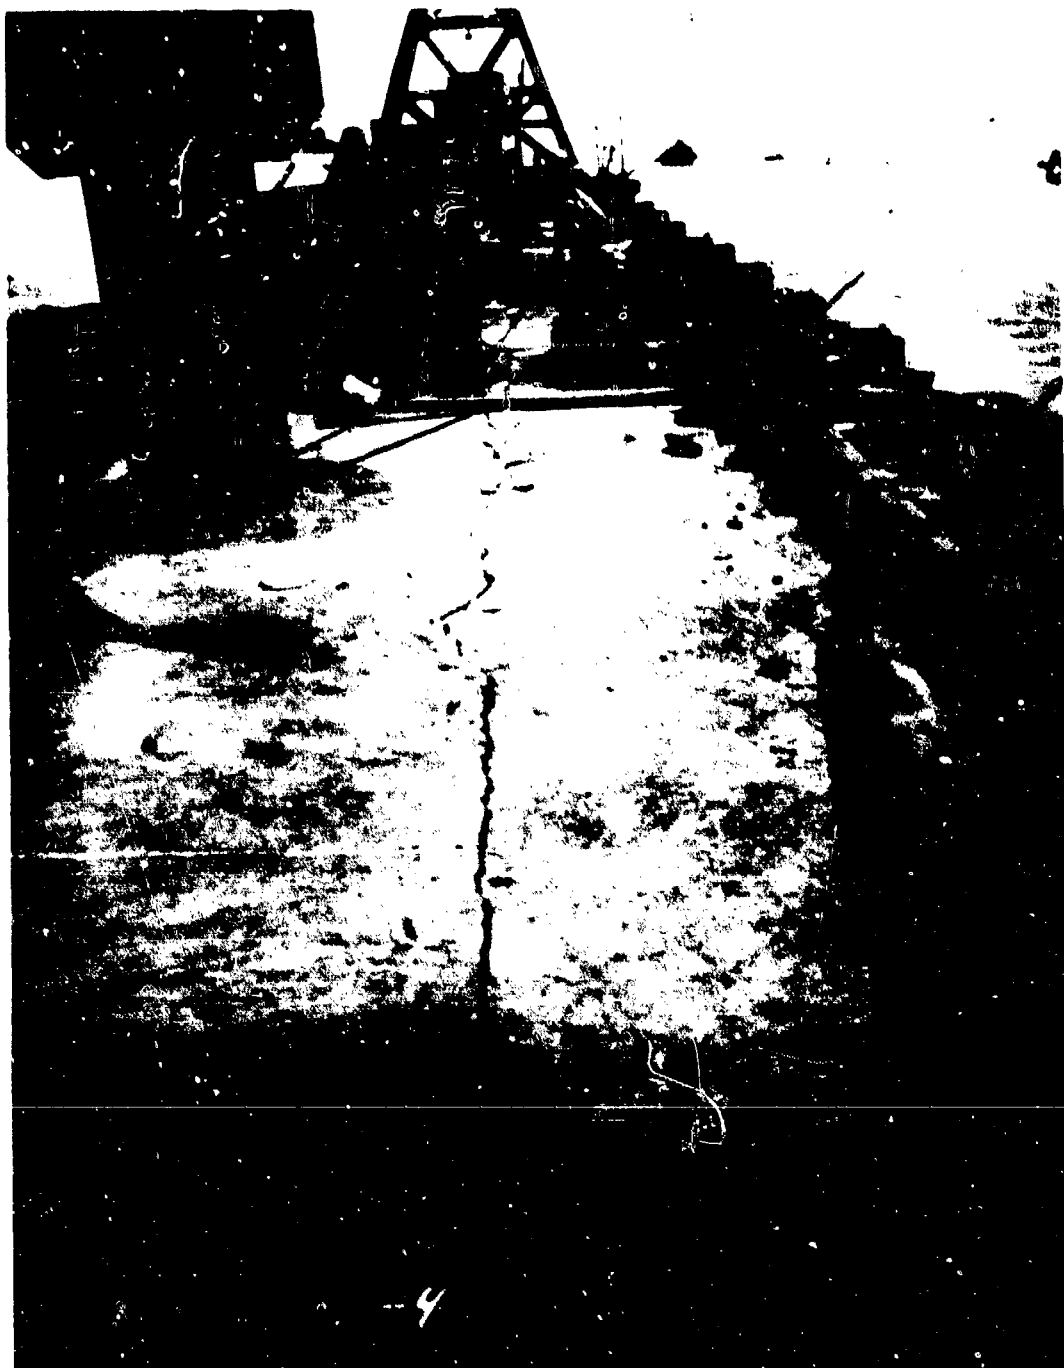
Longitudinal Crack in "A" Deck Port Wing Wall,
Frame 25 Facing Forward

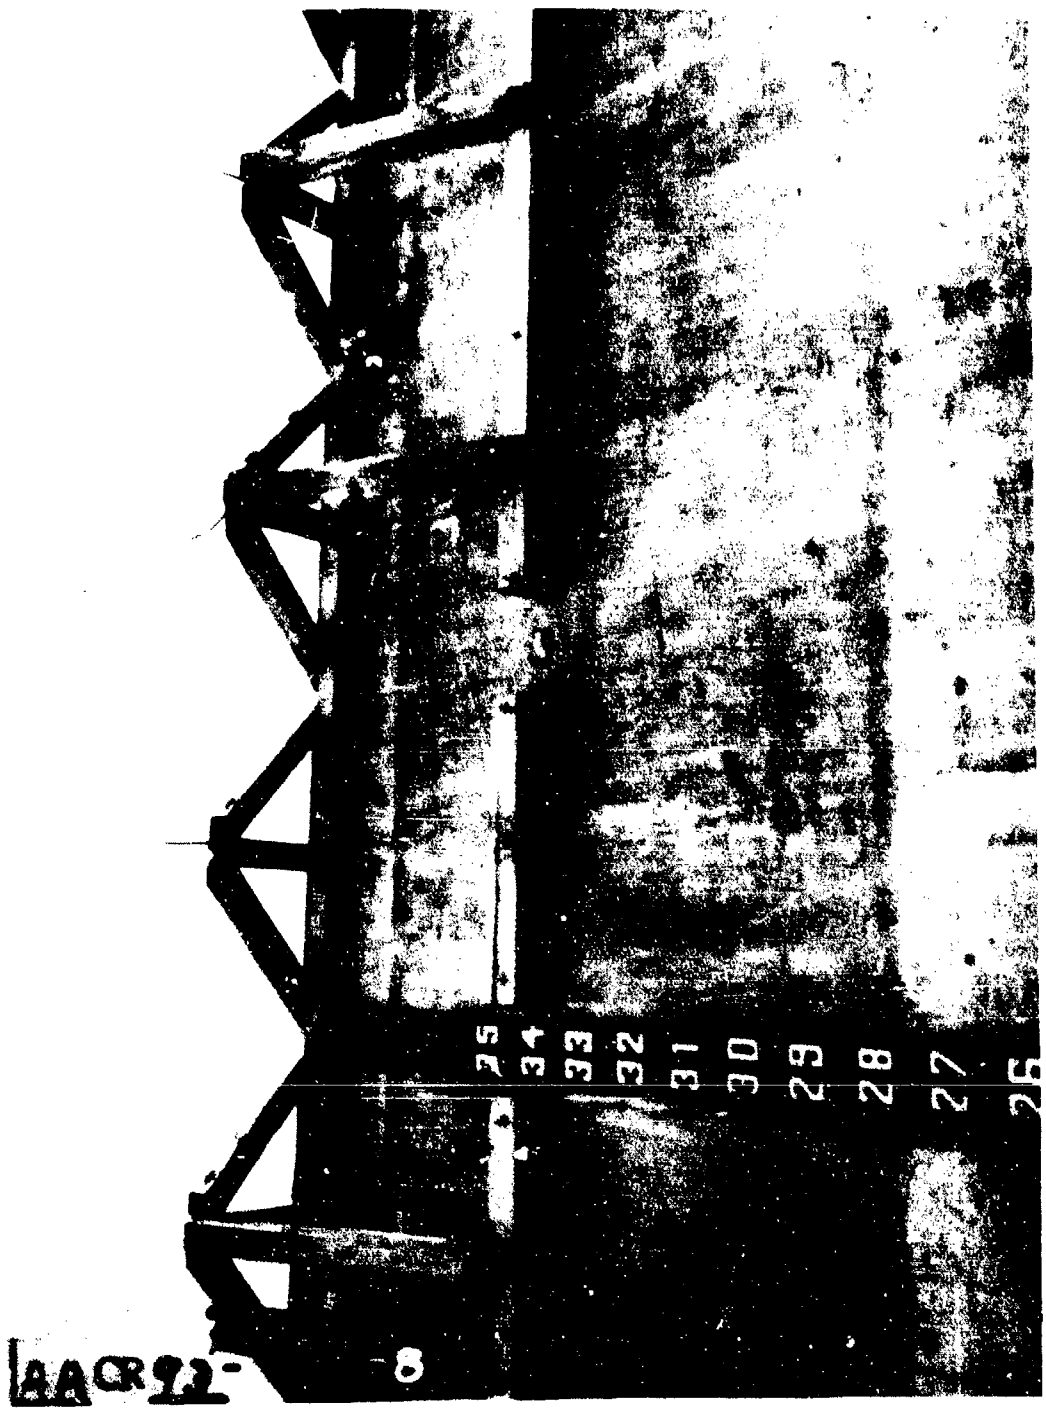
Crack - Inboard Face - Port Wing Wall - Frame 20 - 42 - 2' From Top

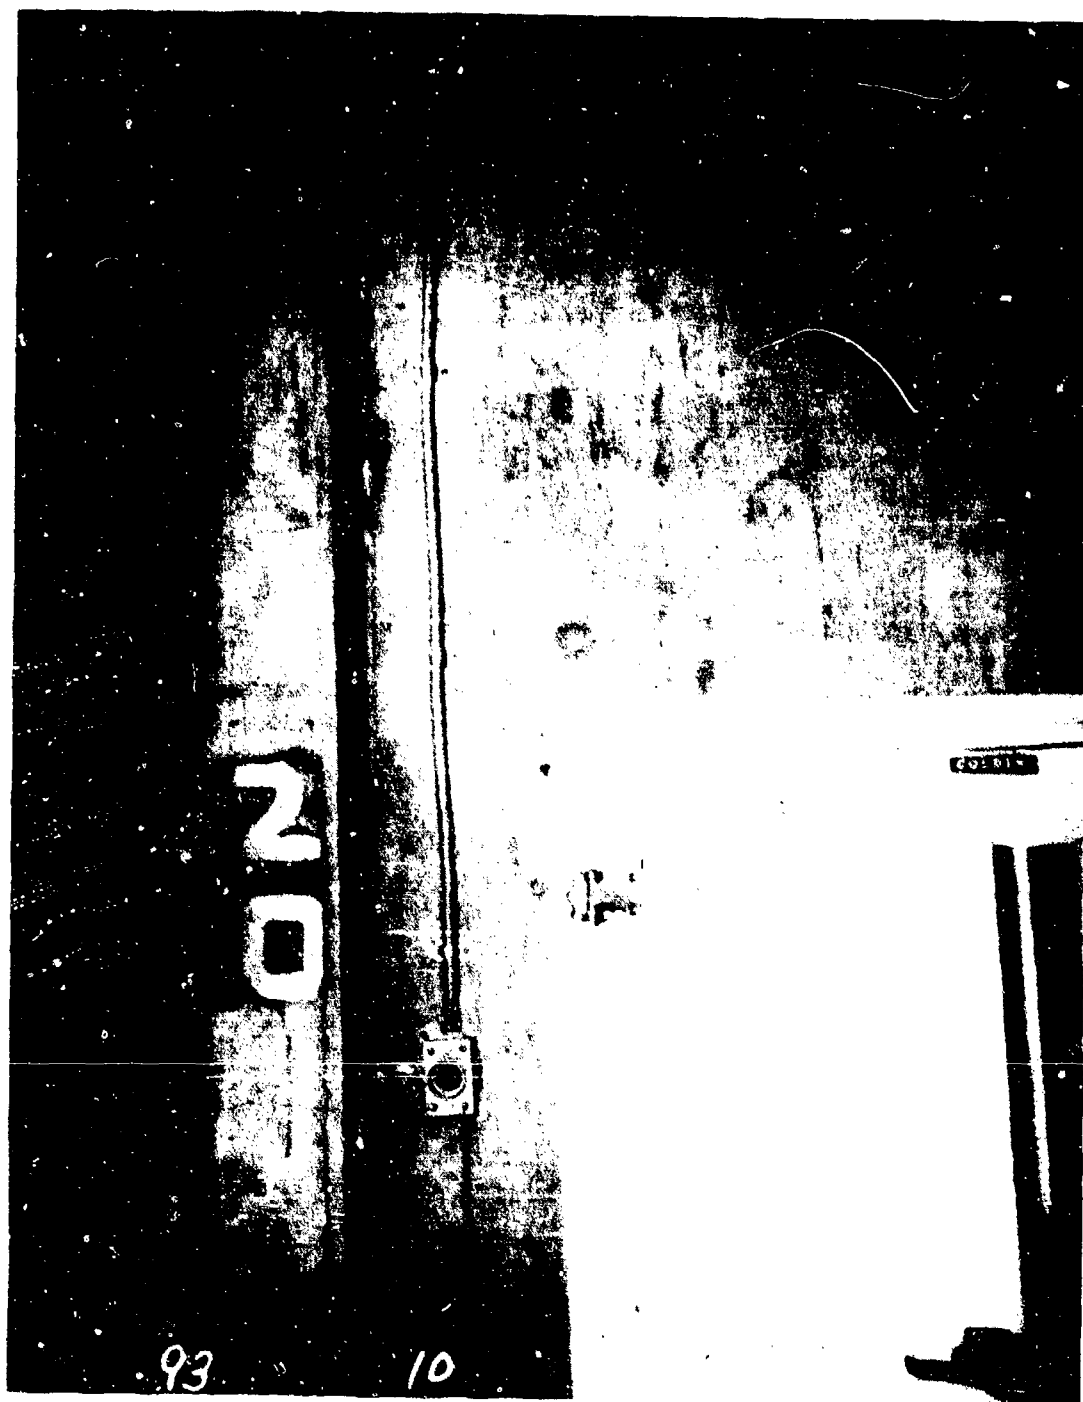
Crack - "B" Level - Port Wing Wall - Frame 20 -
Outboard Wall - Inside Face

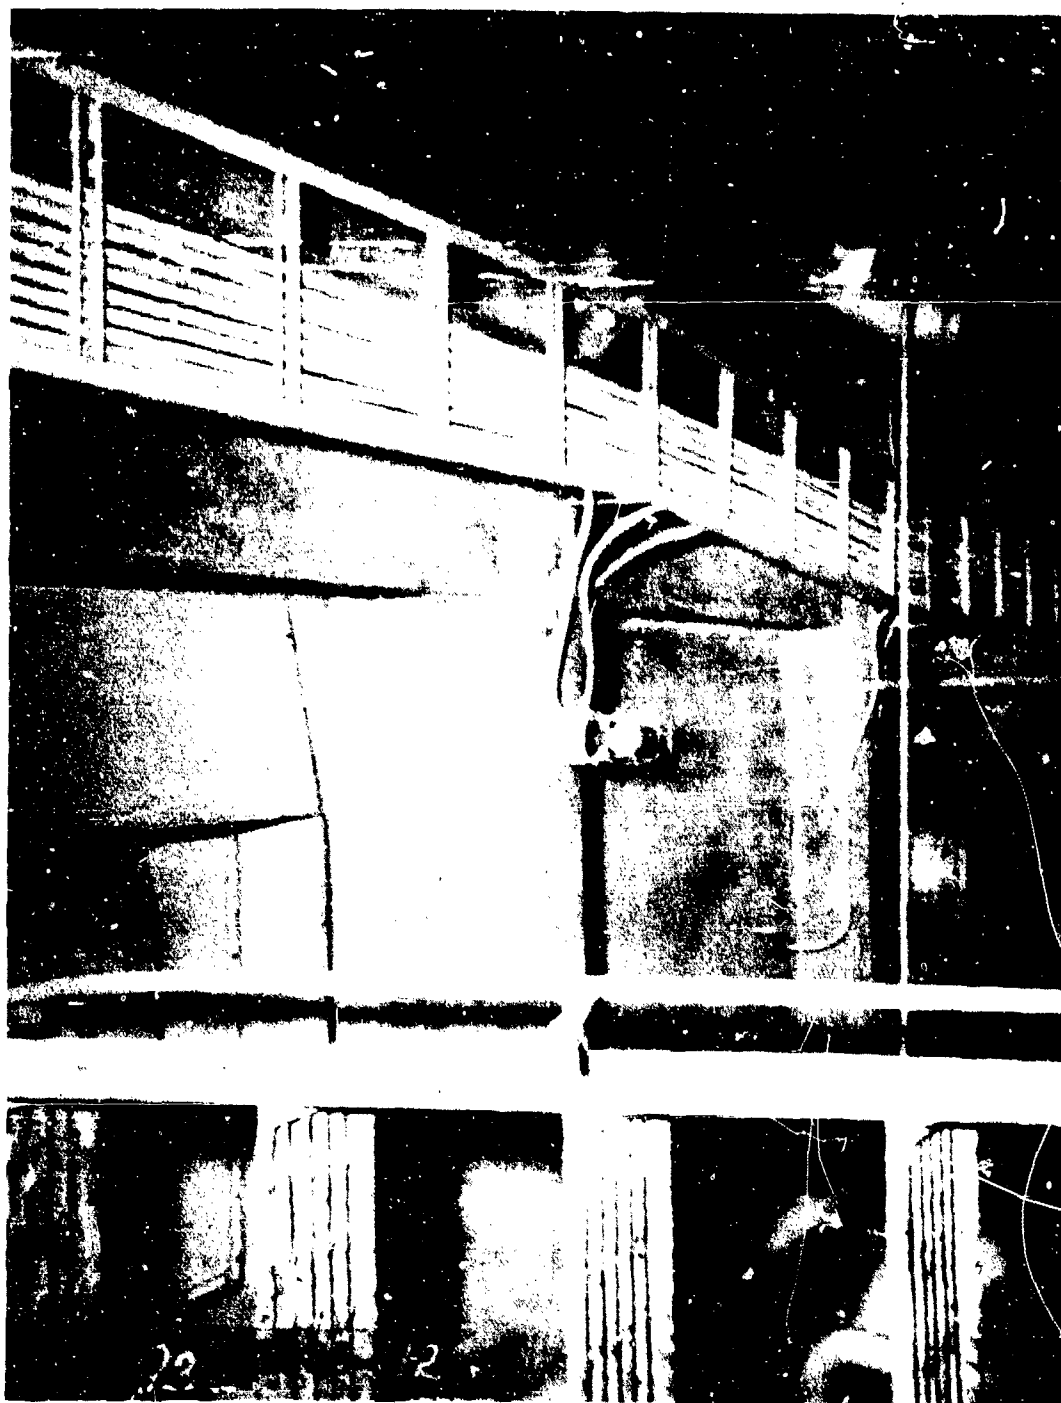
Crack - "B" Level - Port Wing Wall - Frame 24 - Top
